2/22/09

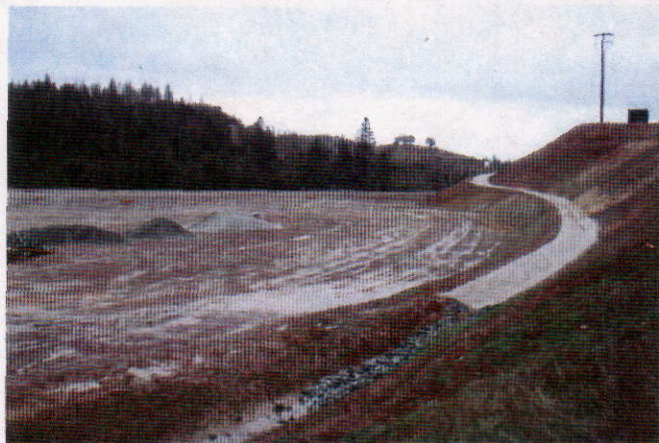
Figure 1: Lack of an effective combination of erosion and sediment control BMPs

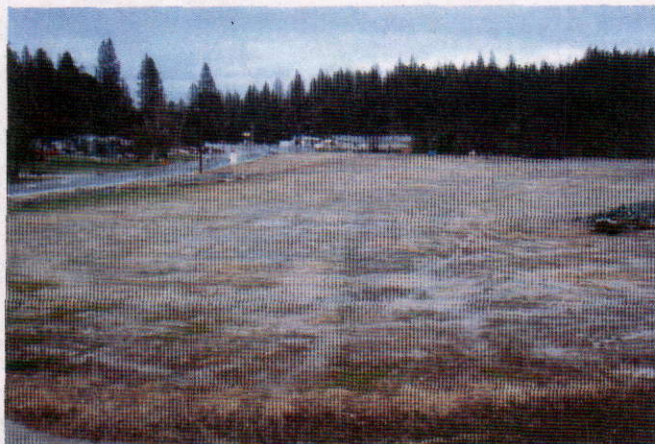
Figure 2: Lack of an effective combination of erosion and sediment control BMPs

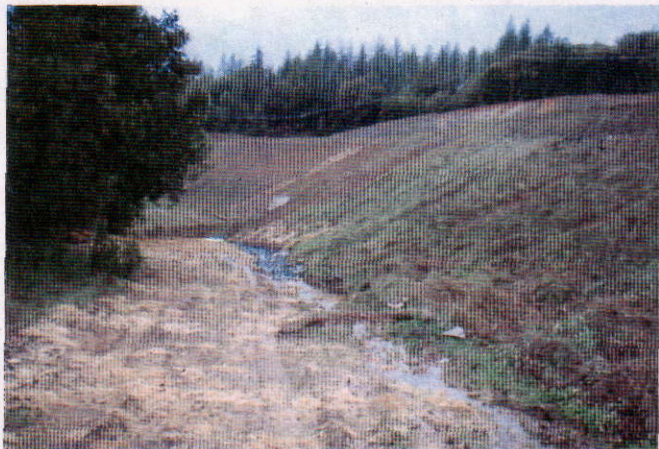
Figure 3: Storm water from the site flowing in a channel adjacent to highway 88 right-of-way

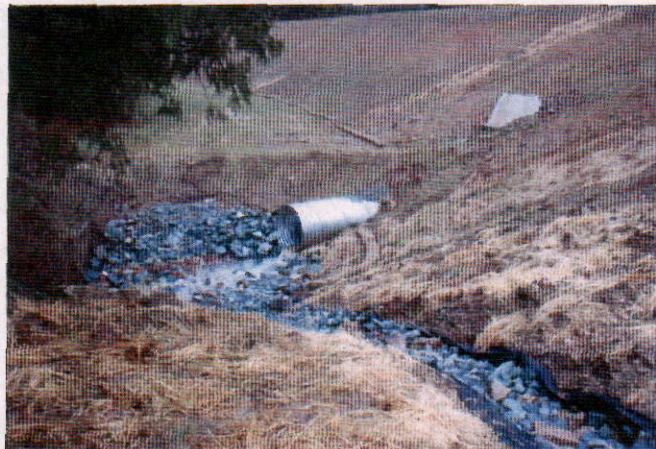
Figure 4: Turbid storm water discharging into the eastern culvert

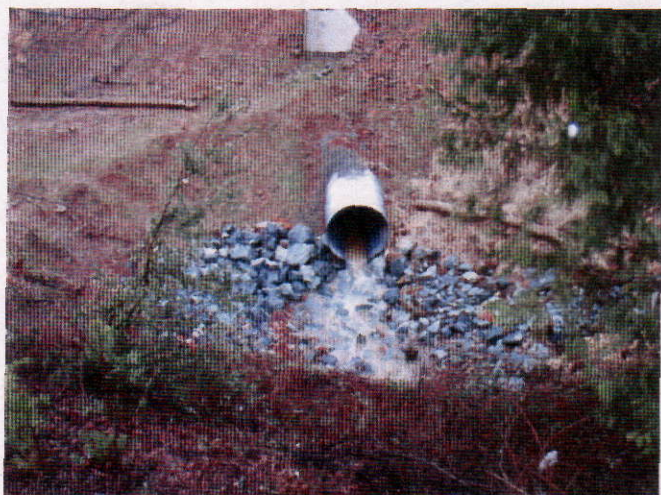
Figure 5: Another view of turbid storm water discharging into the eastern culvert which flows into Jackson Creek

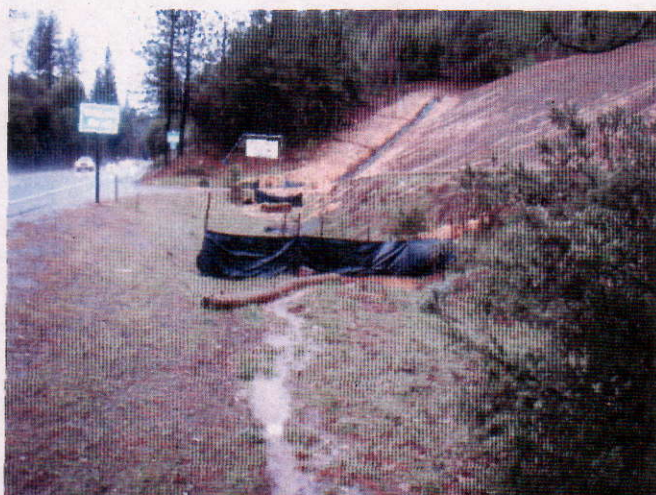
Figure 6: Looking at the western discharge location in the distance

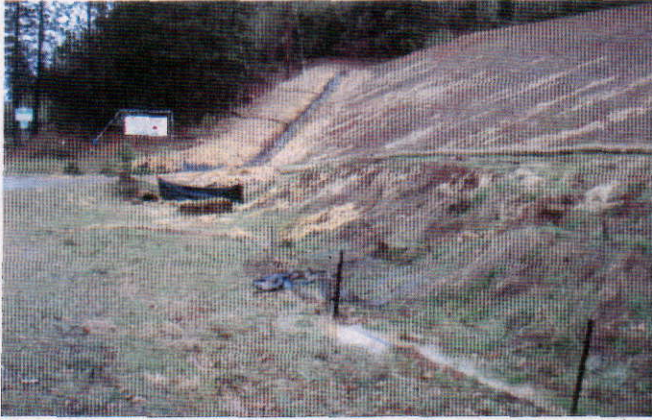
Figure 7: Storm water in the Caltrans right-of-way flowing to the western discharge location

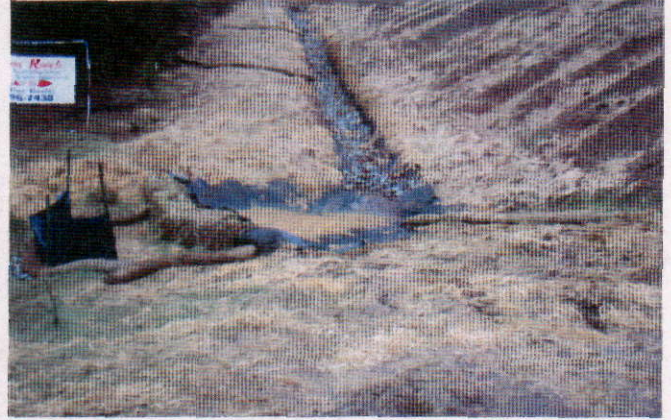
Figure 8: Turbid storm water flowing down to the western discharge location

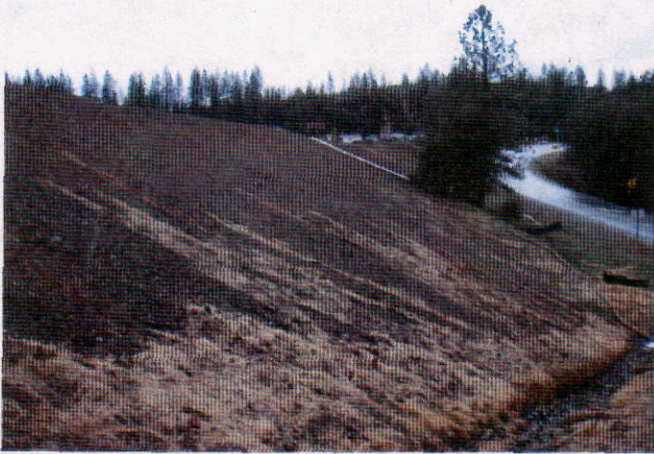
Figure 9: Lack of an effective combination of erosion and sediment control BMPs on the slope adjacent to Highway 88

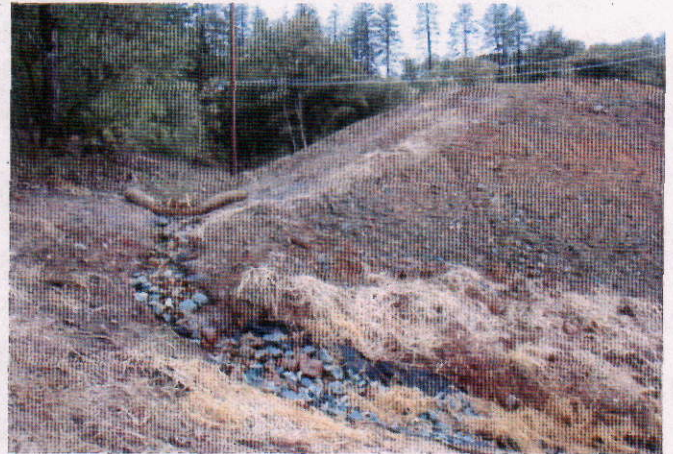
Figure 10: Lack of effective BMPs upslope of the western discharge location Note: the large rill that is forming at the top of the slope

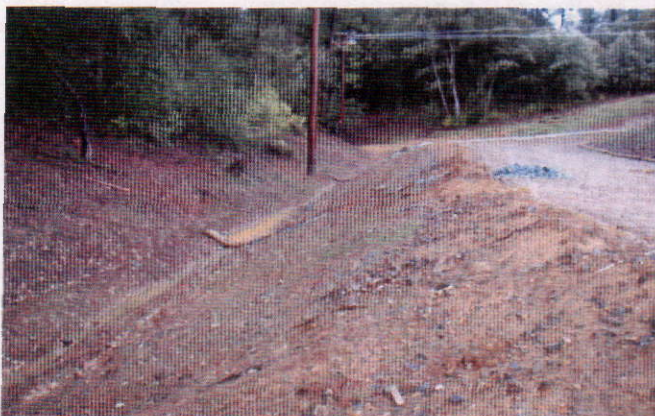
Figure 11: Lack of effective BMPs on top of the slope above the western discharge location

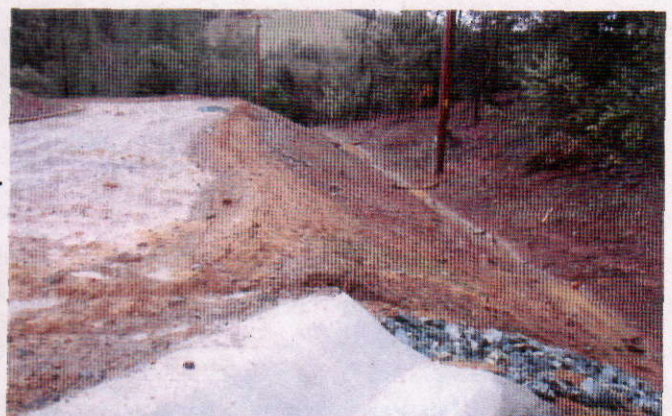
Figure 12: Area where concrete drain along the slope discharges into the area that flows down to the western discharge location Note: the lack of BMPs other than rip-rap

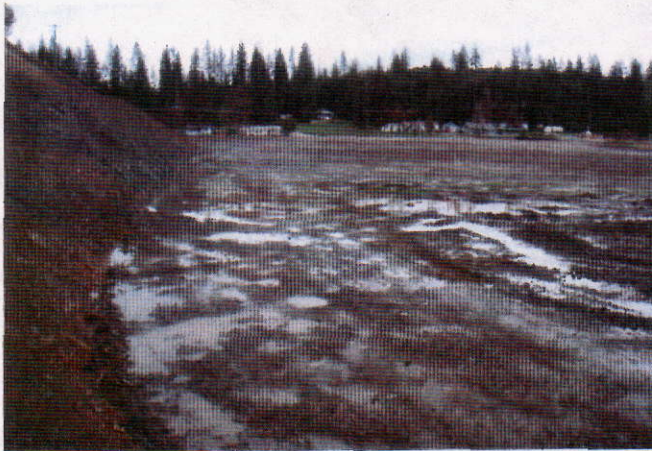
Figure 13: Lack of an effective combination of erosion and sediment control BMPs

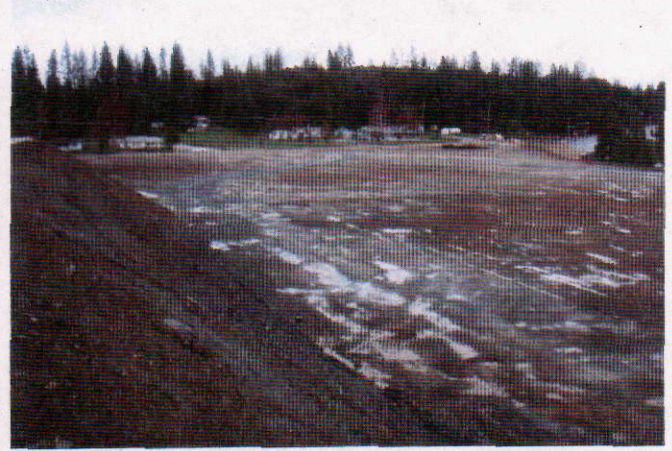
Figure 14: Lack of an effective combination of erosion and sediment control BMPs

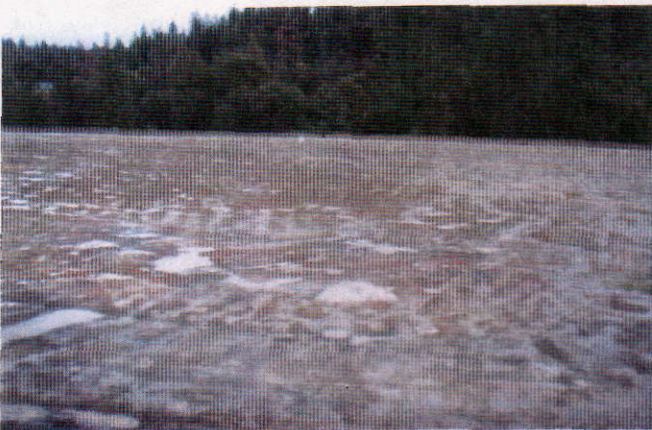
Figure 15: Lack of an effective combination of erosion and sediment control BMPs

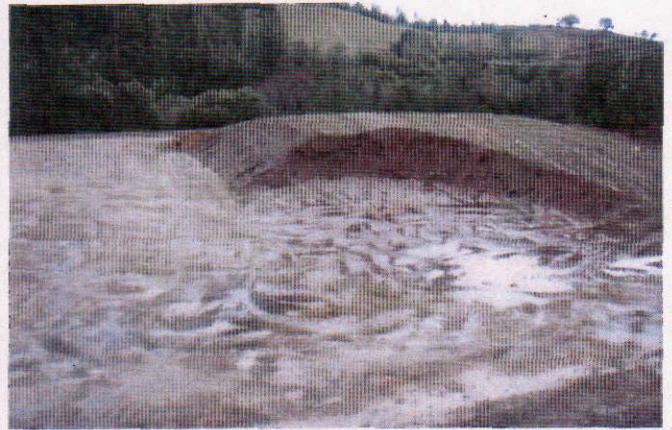
Figure 16: Lack of an effective combination of erosion and sediment control BMPs Note: the poorly stabilized stockpile

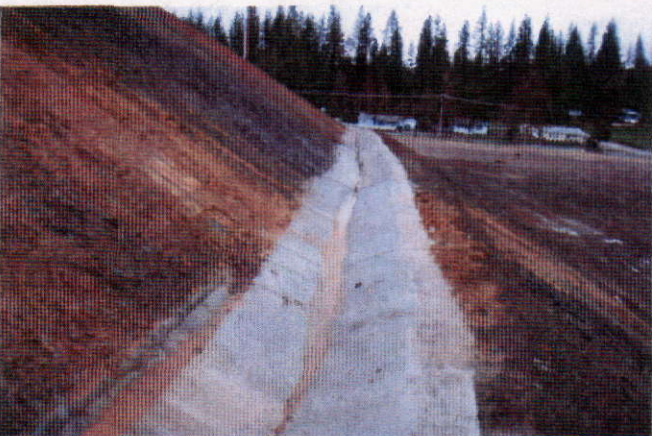
Figure 17: Turbid storm water in the concrete channel that runs along the slope on the northern side of the project

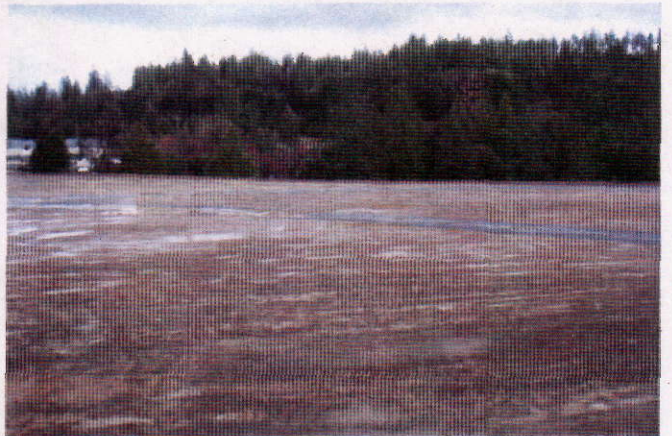
Figure 18: Lack of an effective combination of erosion and sediment control BMPs

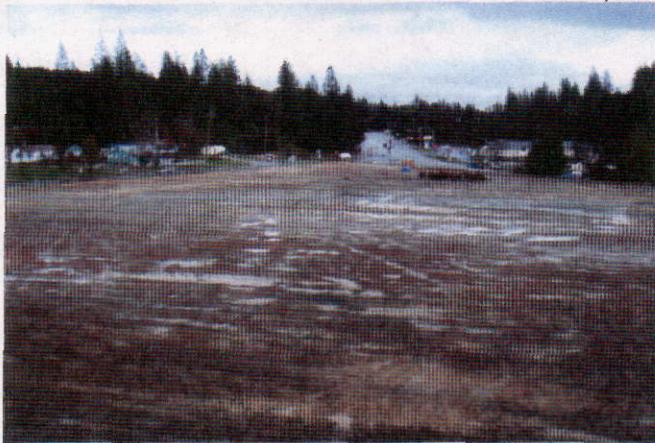
Figure 19: Lack of an effective combination of erosion and sediment control BMPs

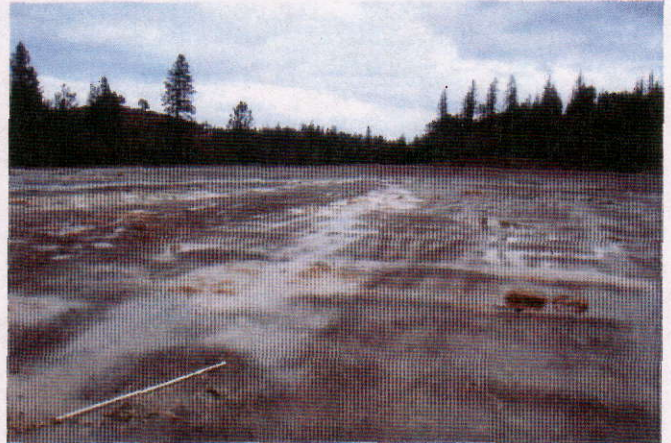
Figure 20: Lack of an effective combination of erosion and sediment control BMPs

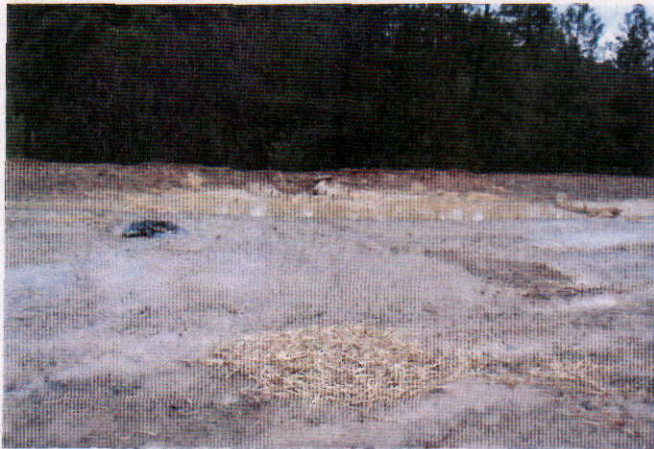
Figure 21: Lack of an effective combination of erosion and sediment control BMPs Note: the turbid storm water ponded adjacent to one of the discharge locations

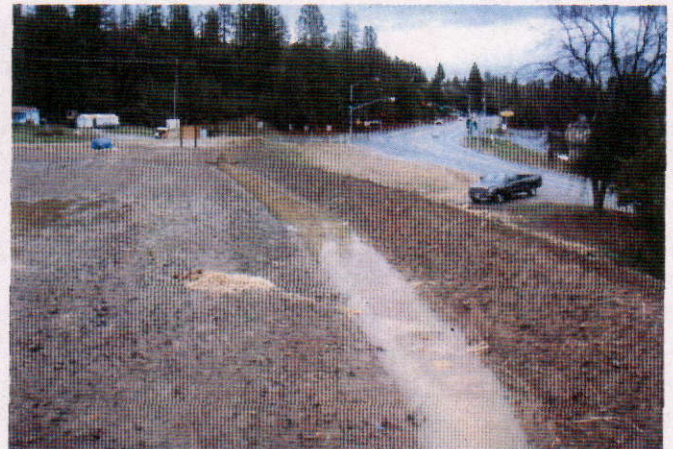
Figure 22: Turbid storm water flowing on the site Note: the lack of effective storm water management BMPs

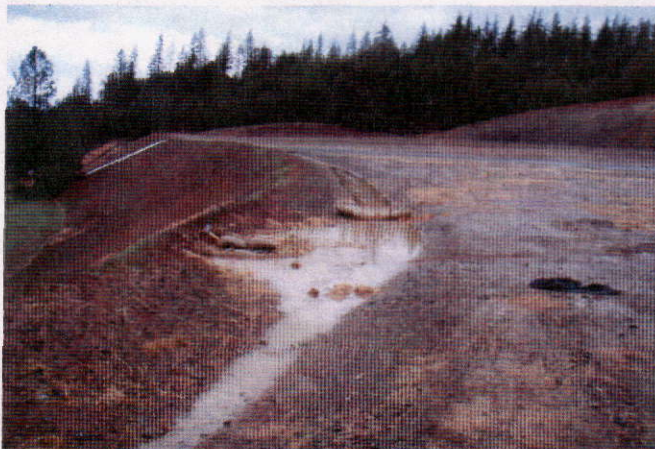
Figure 23: Turbid storm water ponded onsite just prior to discharge into the eastern culvert

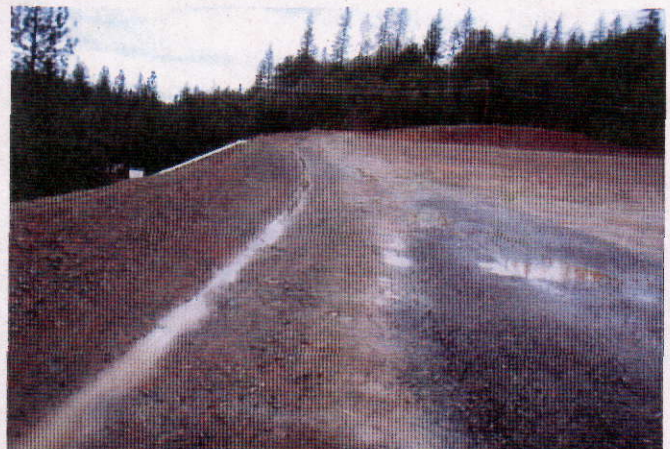
Figure 24: Lack of an effective combination of erosion and sediment control BMPs

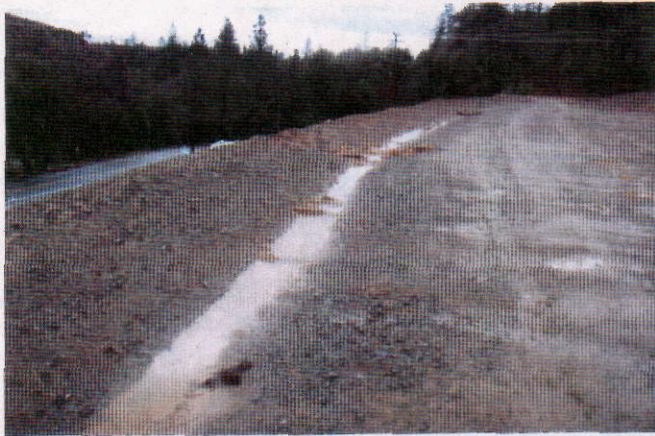
Figure 25: Lack of an effective combination of erosion and sediment control BMPs Note: the only BMPs observed were a few small fiber rolls

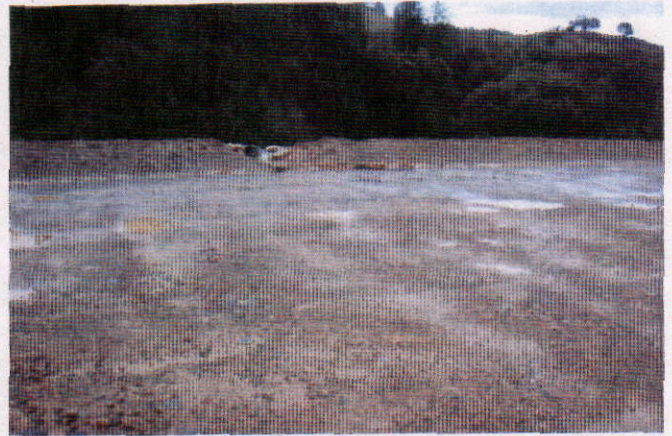
Figure 26: Lack of an effective combination of erosion and sediment control BMPs around one of the discharge locations

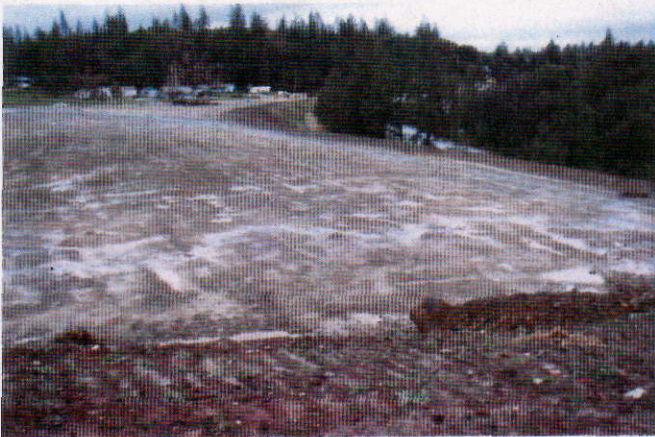
Figure 27: Lack of an effective combination of erosion and sediment control BMPs

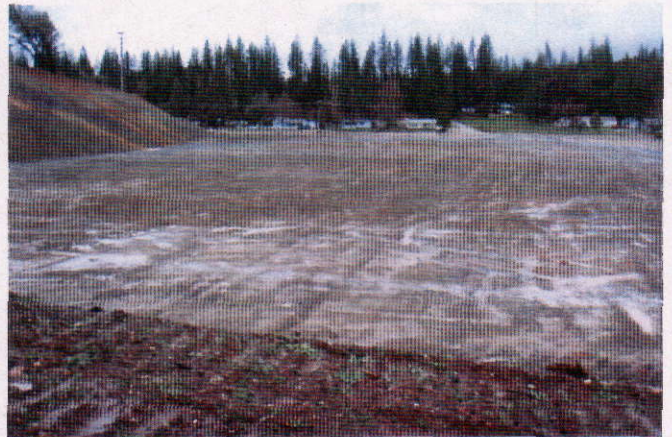
Figure 28: Lack of an effective combination of erosion and sediment control BMPs

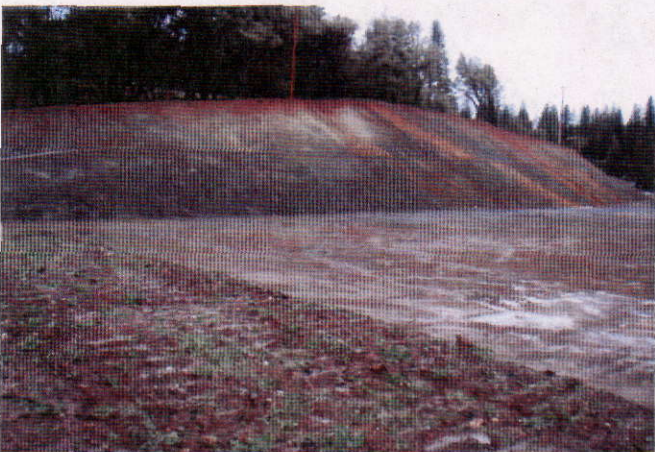
Figure 29: Lack of an effective combination of erosion and sediment control BMPs

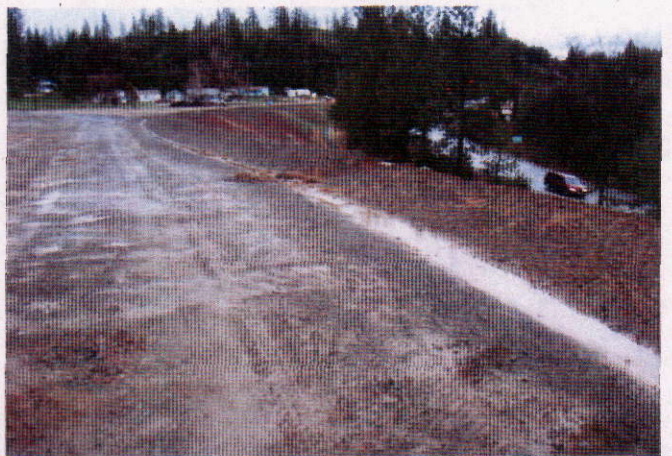
Figure 30: Lack of an effective combination of erosion and sediment control BMPs

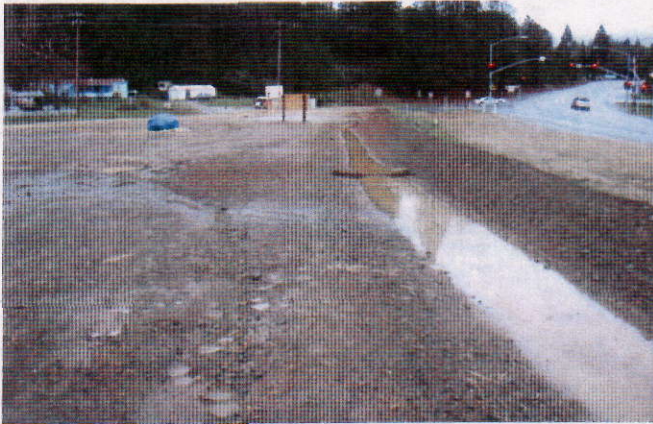
Figure 31: Lack of an effective combination of erosion and sediment control BMPs

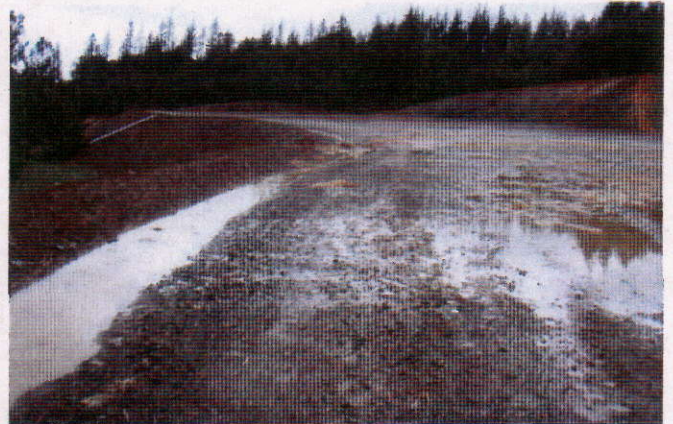
Figure 32: Lack of an effective combination of erosion and sediment control BMPs

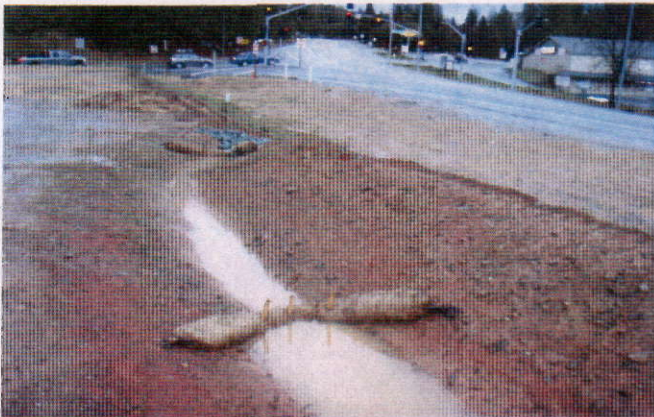
Figure 33: Turbid storm water discharging from the project

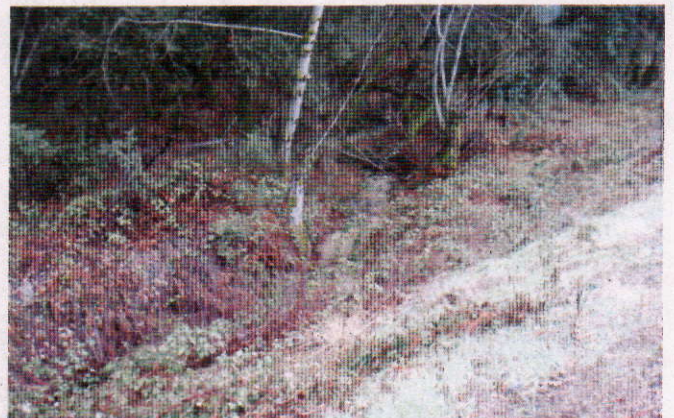
Figure 34: Turbid storm water from the site flowing into Jackson Creek

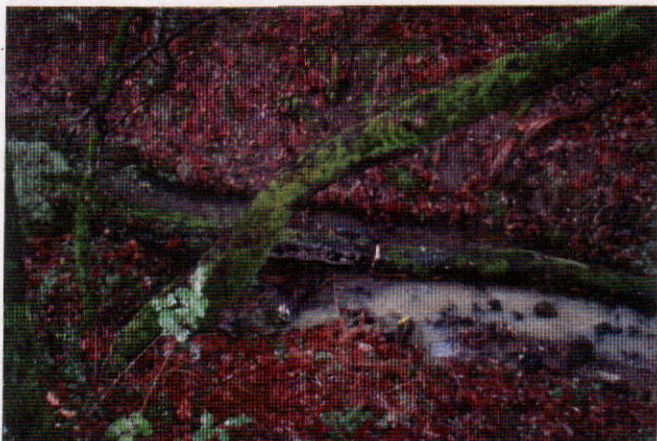
Figure 35: Turbid storm water from the site mixing with clean storm water in Jackson Creek

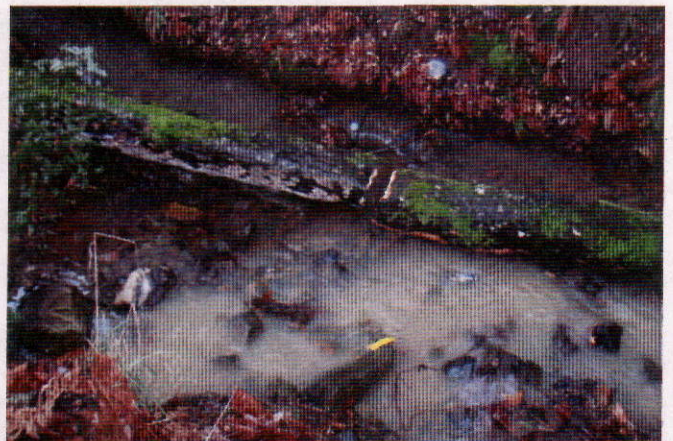
Figure 36: Turbid storm water from the site mixing with clean storm water in Jackson Creek
